Manhole Inspection Summary

Manhole # S31S1_017MH

Location Address: **3520 Spelman Road**

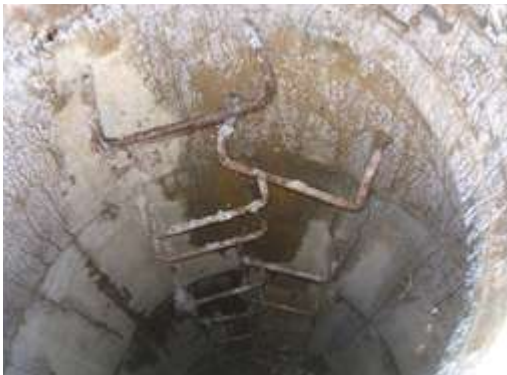
Steps Count: **14** Missing: **0** ☐ Corroded

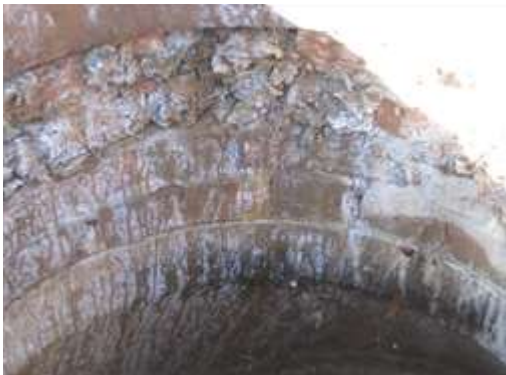
Defect 1

Infiltration: ☐ None ☐ Joint ☐ Cracks ☒ **Mortar** ☐ Roots ☐ Wall

Infiltration

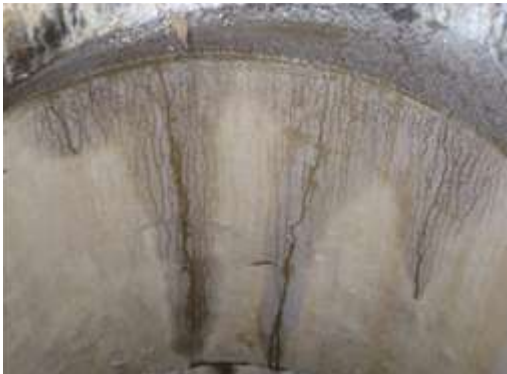
Defect 2

Infiltration: ☐ None ☐ Joint ☐ Cracks ☐ Mortar ☐ Roots ☒ **Wall**

Wall

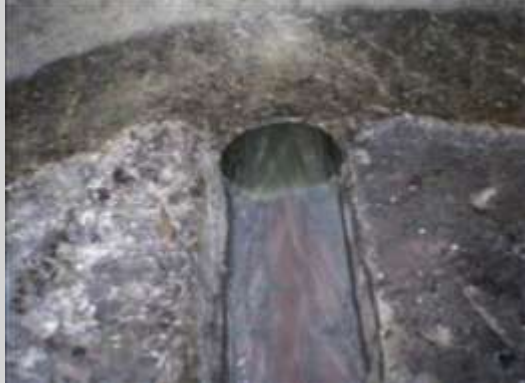
12 O'Clock Outflow

8 in. Circular Gravity Sewer
Pipe Out @ 12 O'Clock

Pipe Height: **10.8** (in.) Rod and Bar (Angled)
Pipe Material: **PVC** ☐ Pipe Lined
Invert Depth: **16.79** (ft.) Flow Characteristics: **Fast**
Deposits: ☒ None ☐ Mud ☐ Sludge ☐ Debris ☐ Grease
Silt Depth: (in.) Deposits Extent:
Infiltration: **None** Pipe Seal Cond: **Sound**

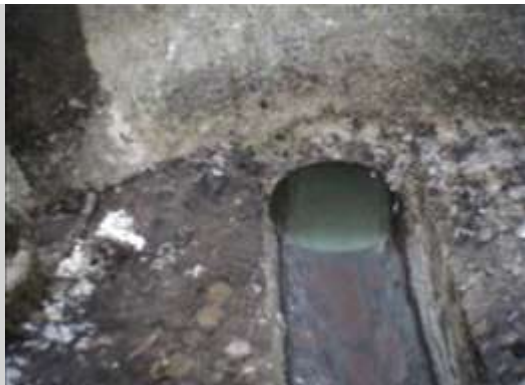
6 O'Clock Inflow

8 in. Circular Gravity Sewer
Pipe In @ 6 O'Clock

Pipe Height: **9.6** (in.) Rod and Bar (Angled)
Pipe Material: **PVC** ☐ Pipe Lined
Invert Depth: **16.48** (ft.) Flow Characteristics: **Fast**
Deposits: ☒ None ☐ Mud ☐ Sludge ☐ Debris ☐ Grease
Silt Depth: (in.) Deposits Extent:
Infiltration: **None** Pipe Seal Cond: **Sound**
